# **Examination of Failed One Inch Black Iron Pipe Natural Gas Service Line, Iowa Public Service Company, Eagle Grove, Iowa**

T. Robert Shives

August 30, 1973

Failure Analysis Report

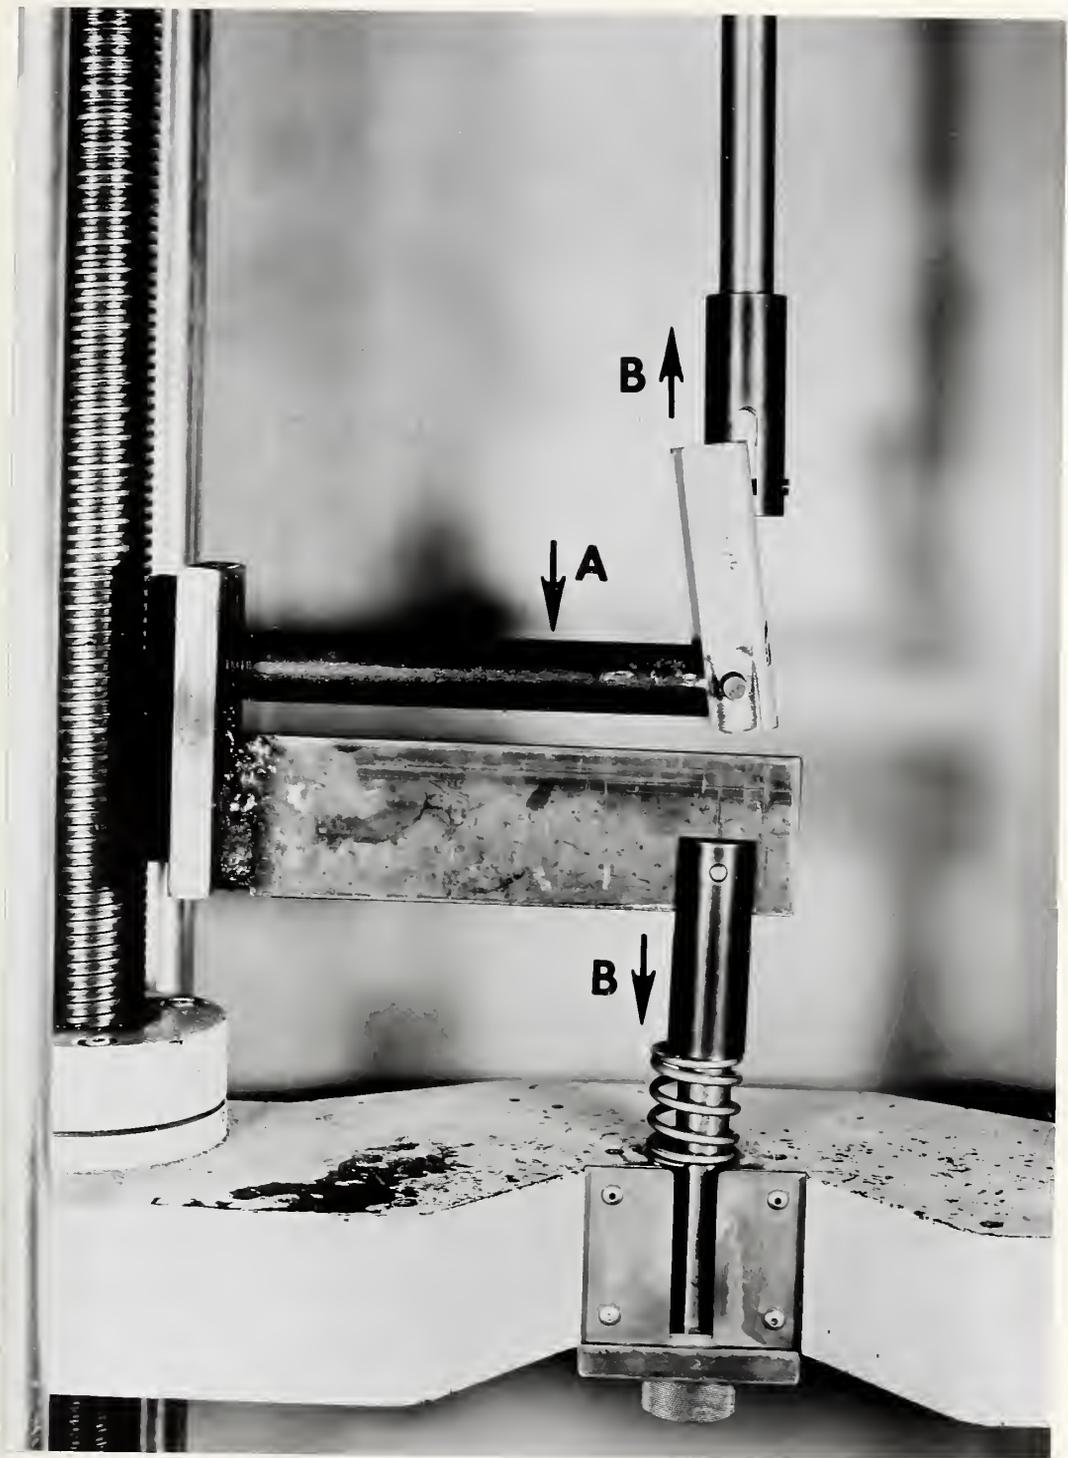
Figure 2. Setup for bend test of pipe length. Pipe specimen is indicated by arrow A. Arrows B indicate the direction of load application. The specimen is threaded on the left end.

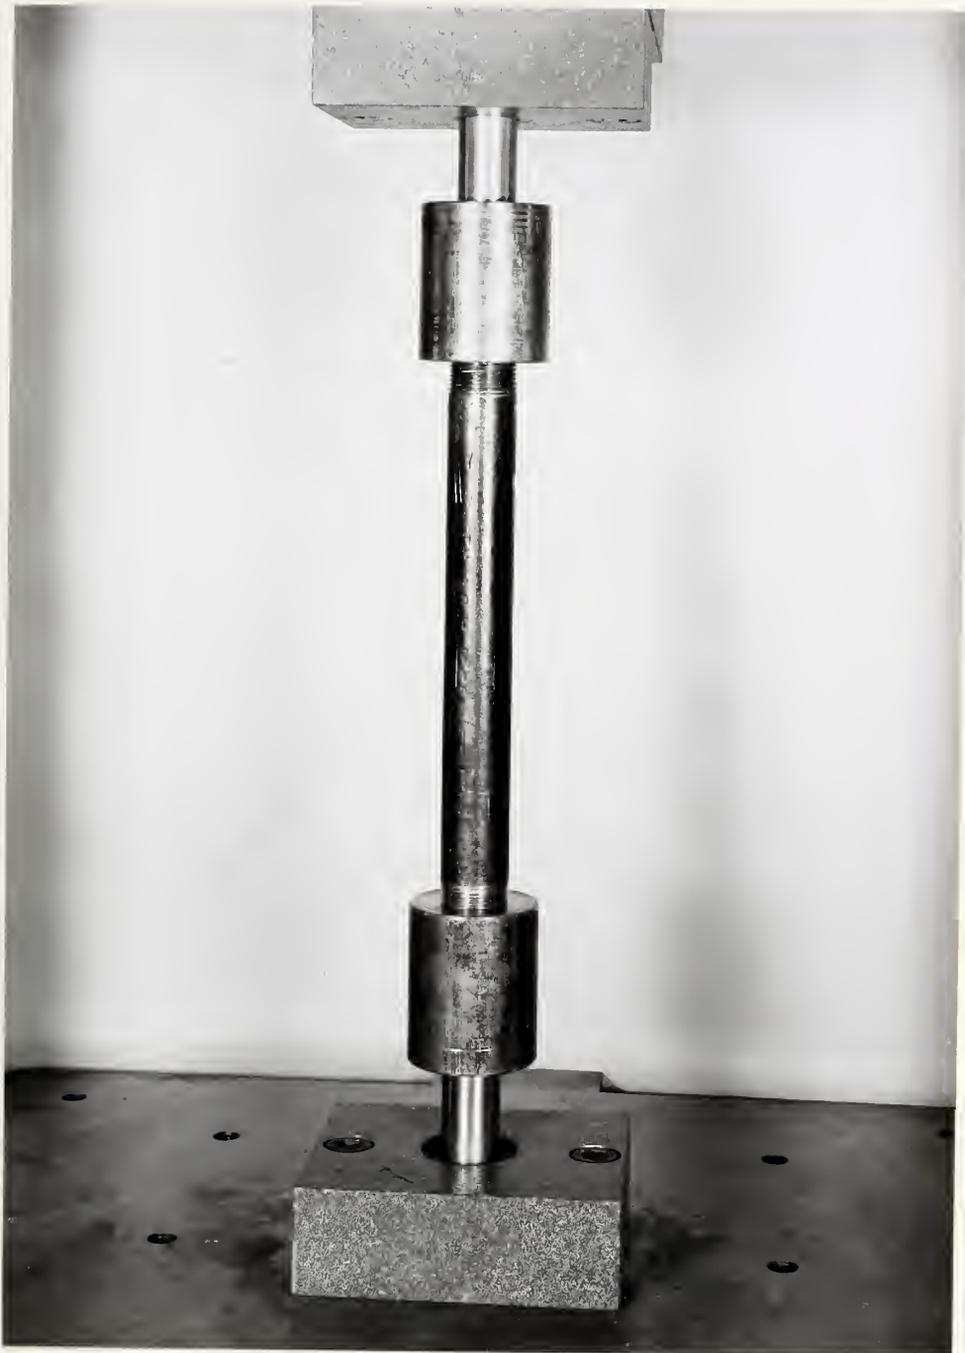
Figure 3. Setup for uniaxial tensile test of pipe length. Pipe is threaded on both ends.
